**Re: GE-Pittsfield/Housatonic River Site  
Silver Lake Area (GECD600)  
2018 Annual Monitoring Report**

# 2018 ANNUAL MONITORING REPORT

Silver Lake Area

February 2019

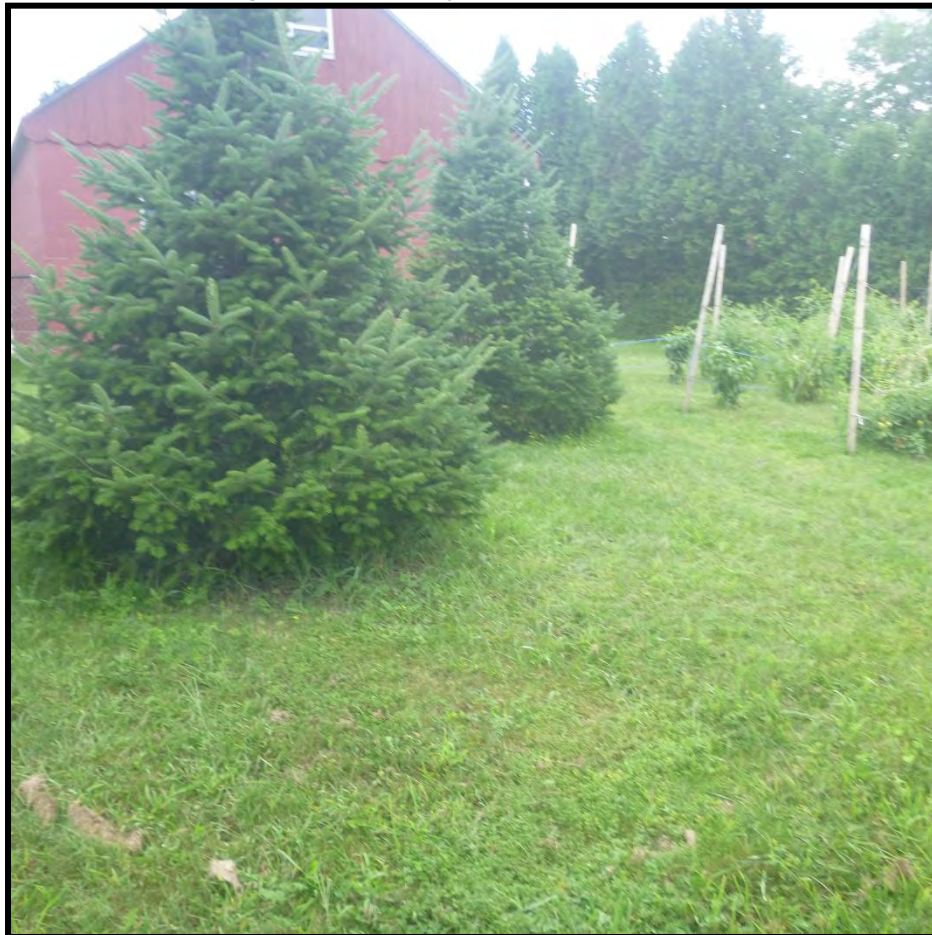
The summer 2018 inspection included observations and counts of the two trees noted above to assess the number, survival, and condition of those plantings. Table 2 summarizes the results of the observations/counts of the monitored shrubs and trees. As shown in that table, the two Fraser firs planted on Parcel I9-9-28 on May 31, 2016 were observed to be alive and healthy (Photograph 3, Attachment C). As the monitoring duration for the replanted trees was reset to two years after planting, the summer 2018 inspection constituted the final monitoring event for these trees and given the health of the trees no further action is required at this time.

Photograph 3: Fraser firs trees looking alive and healthy on Parcel I9-9-28.

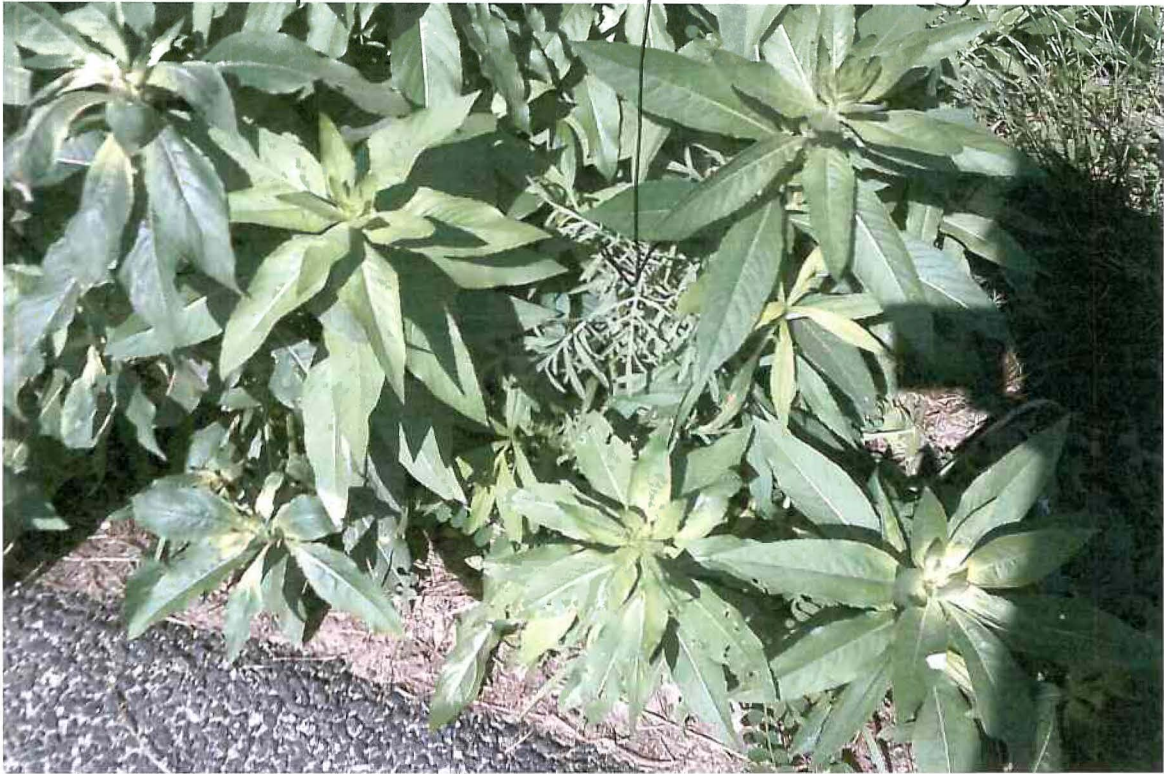
Spotted Knapweed Seedling

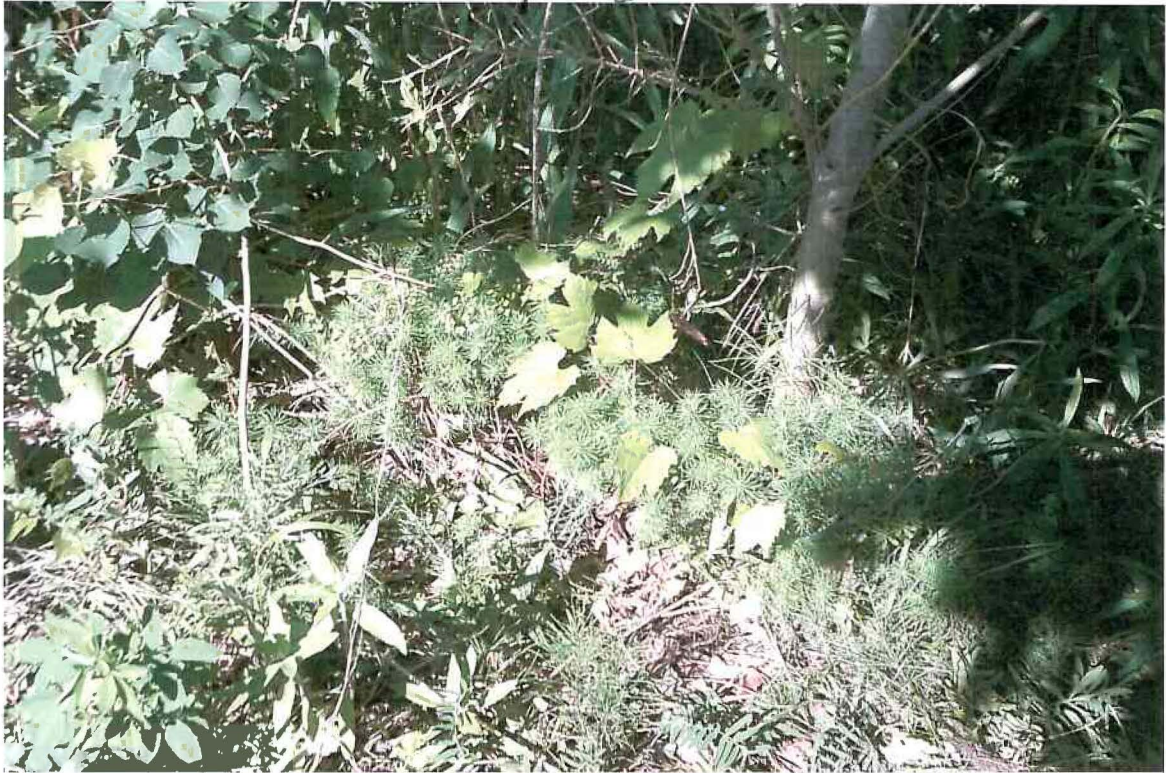
Cypress Spurge

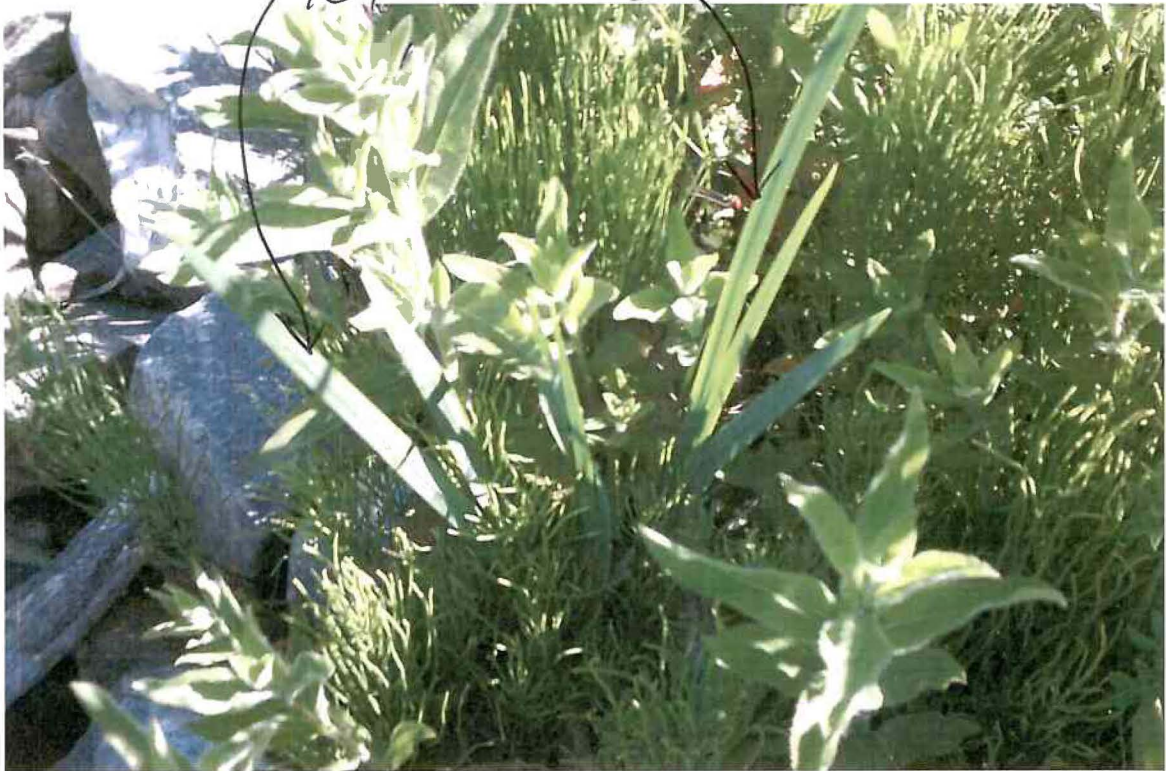
Yellow Iris

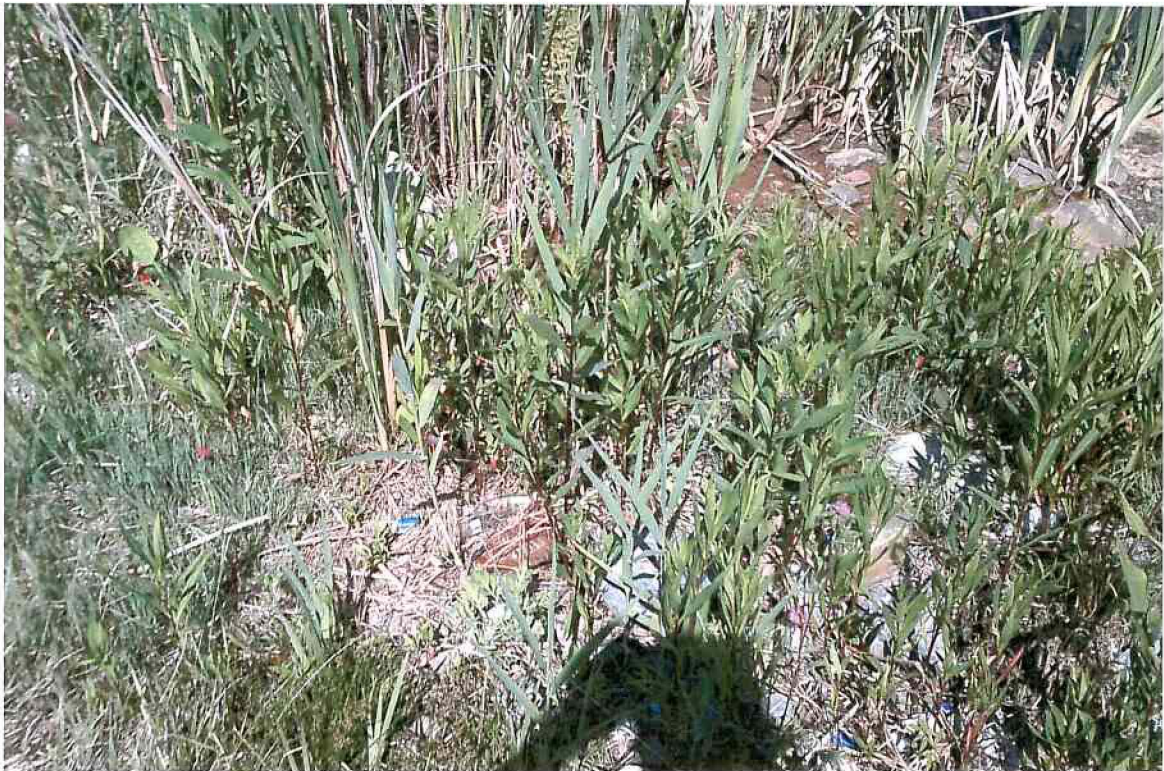
PHRAGMITES,

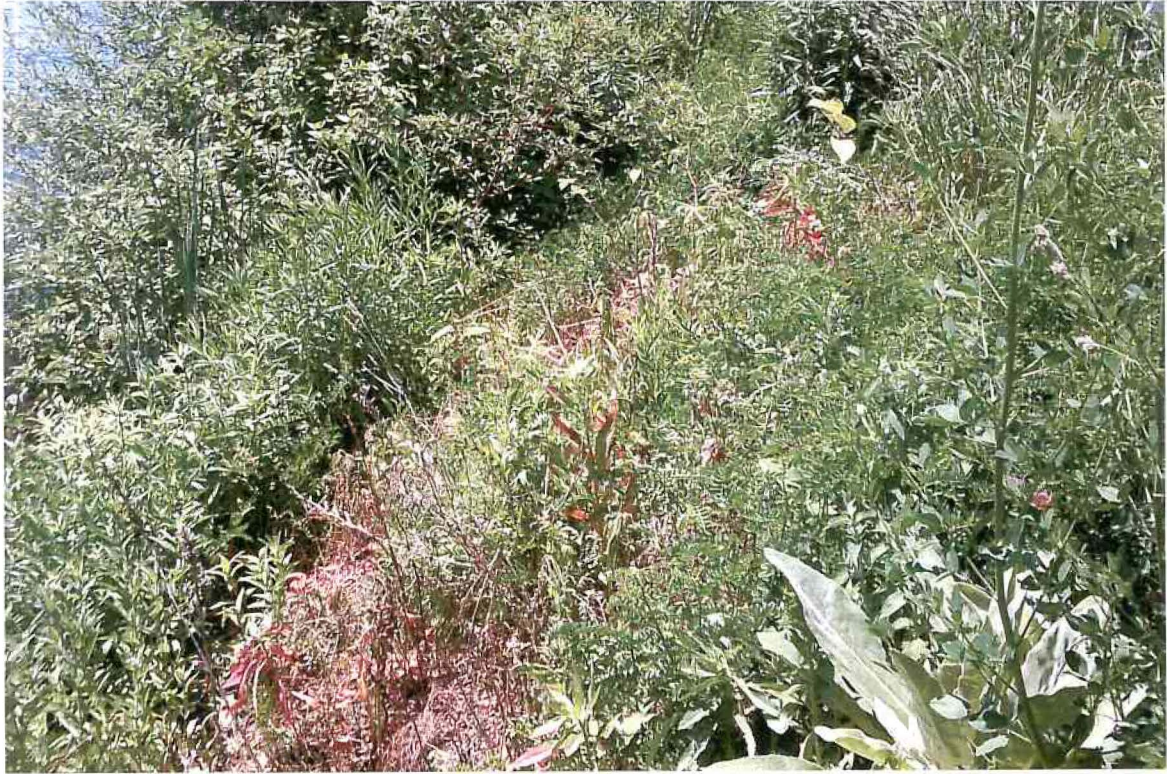
Japanese Knotweed Patch treated last  
Apr.

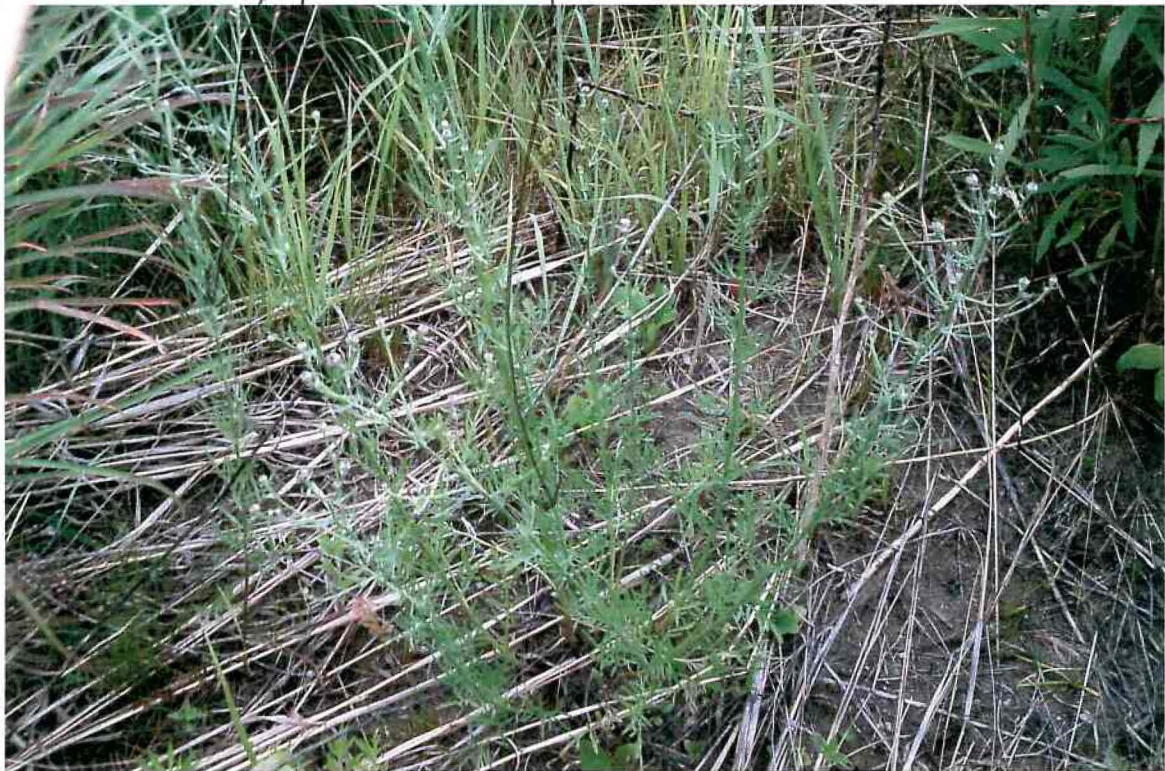
Spotted Knapweed Seedlings

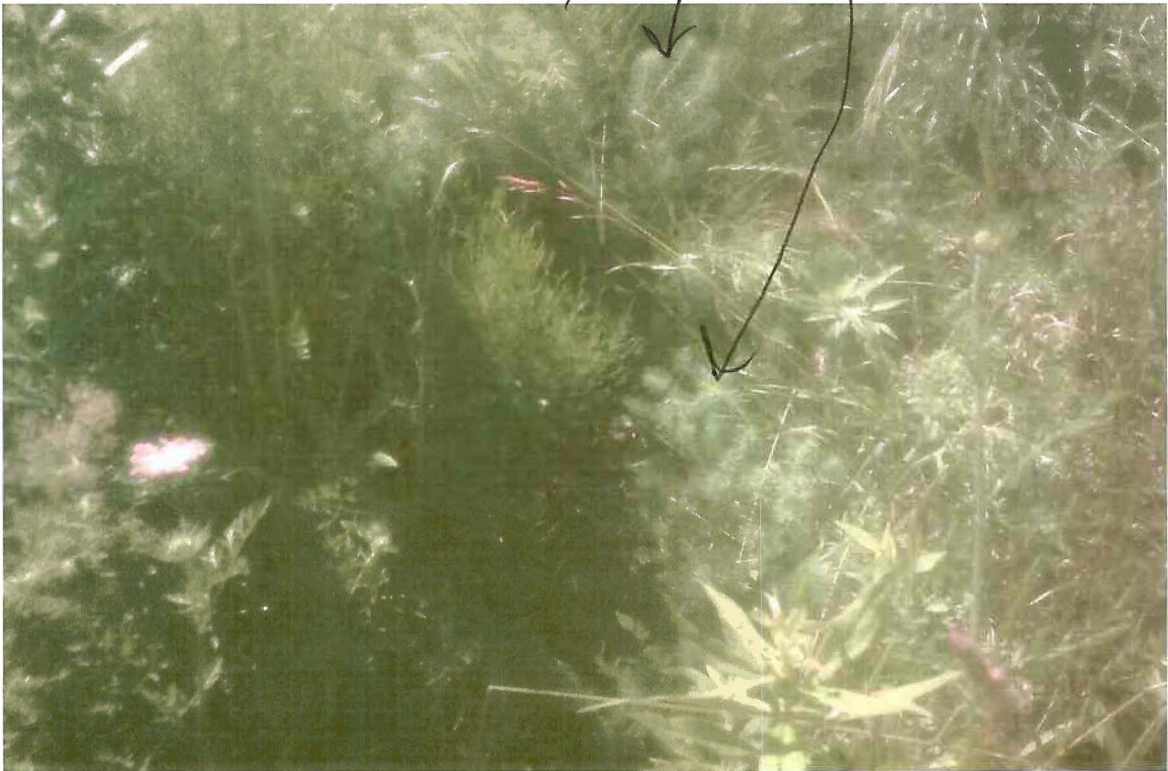
Cypress Spurge

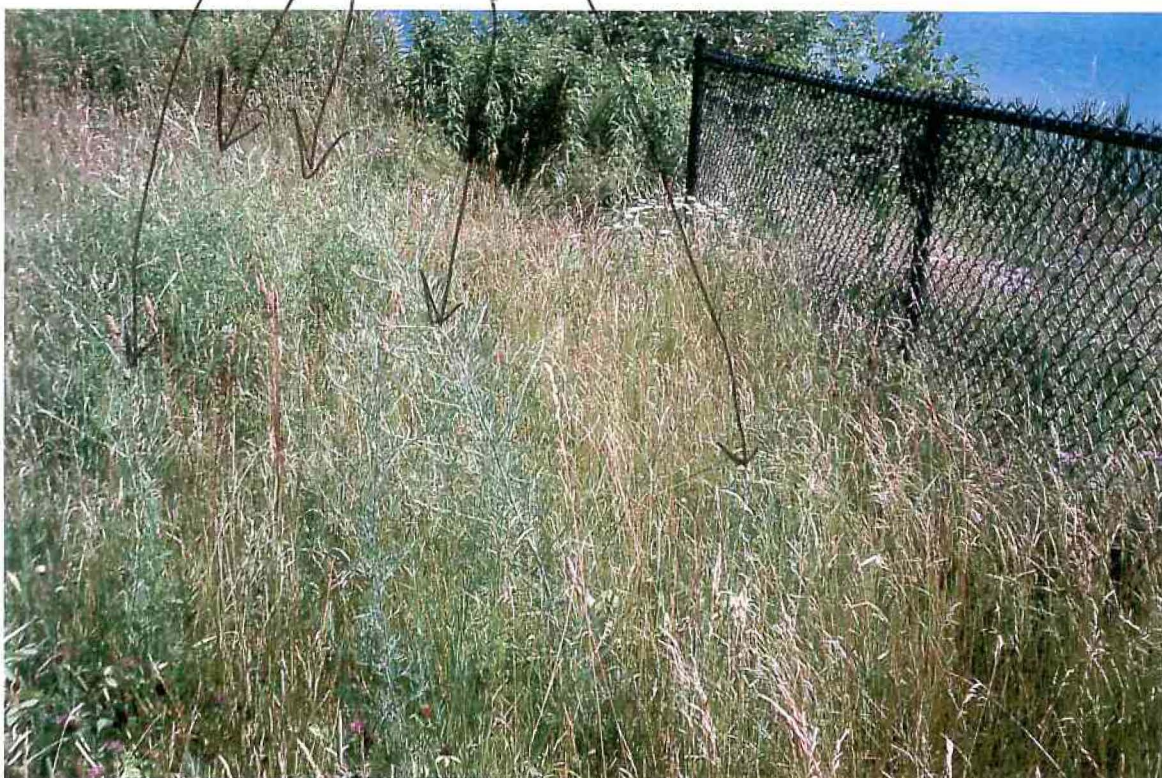
Spotted Knapweed

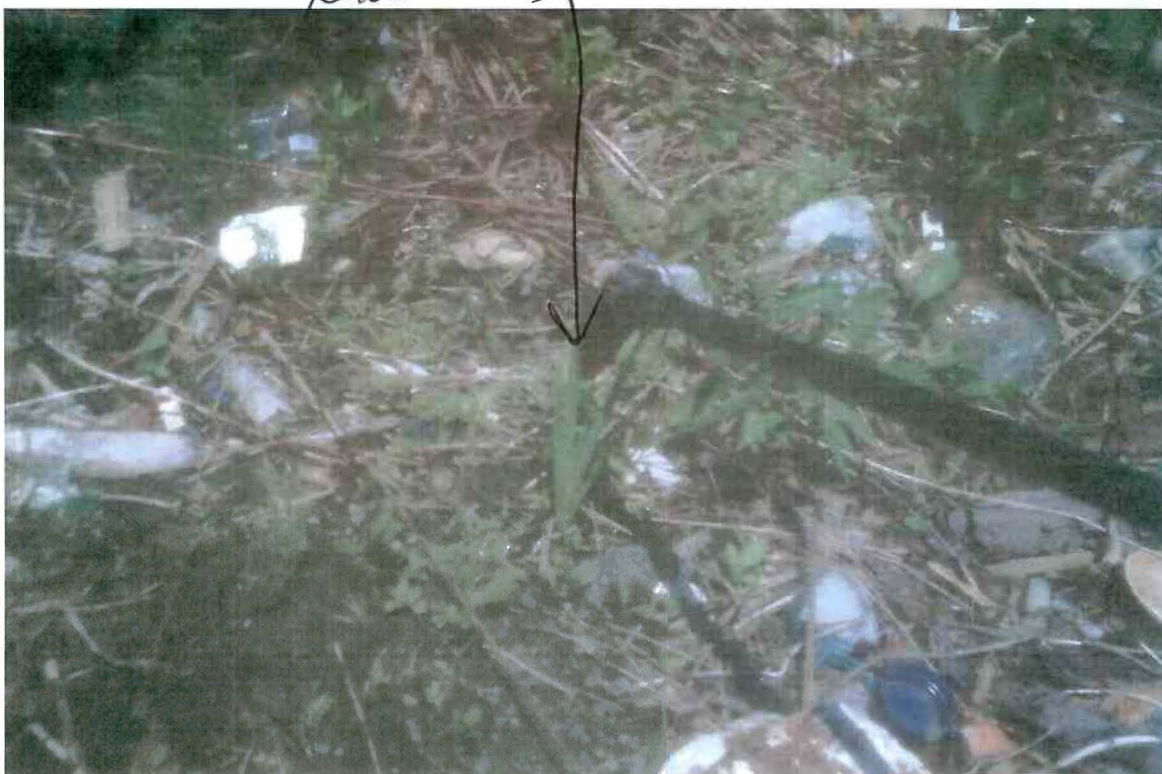
Yellow Iris

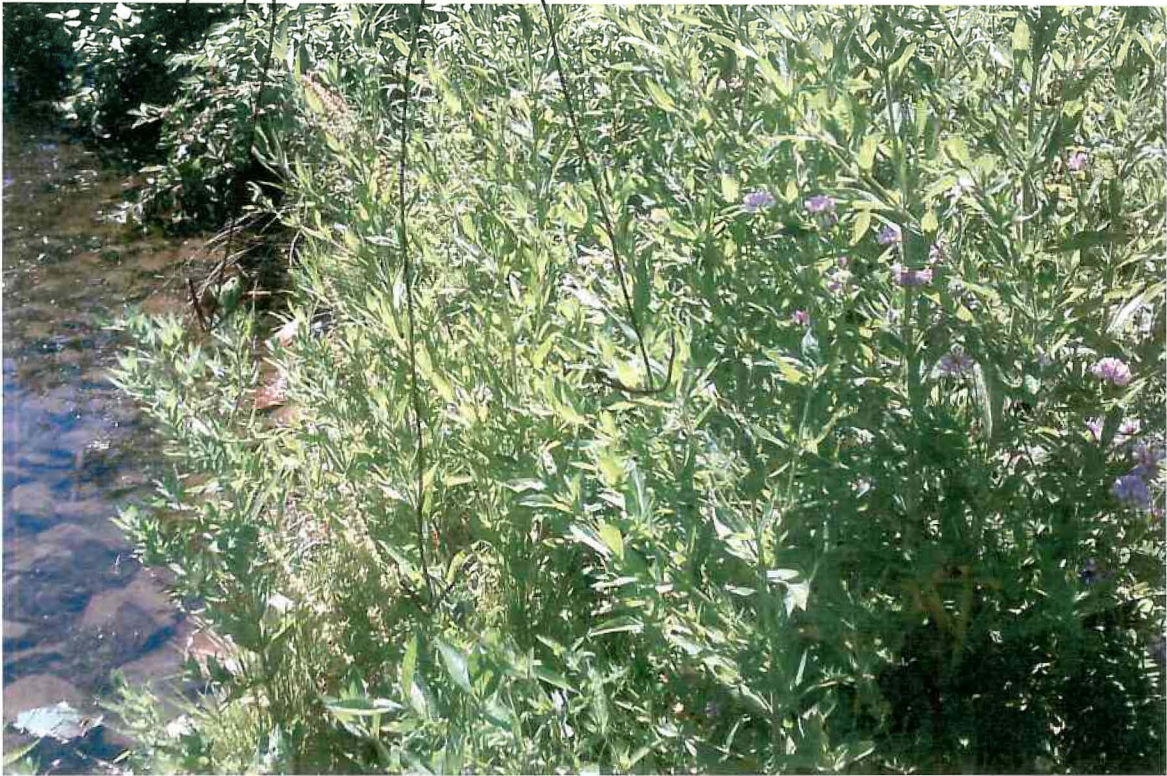
PURPLE LOOSESTRIFE !!!

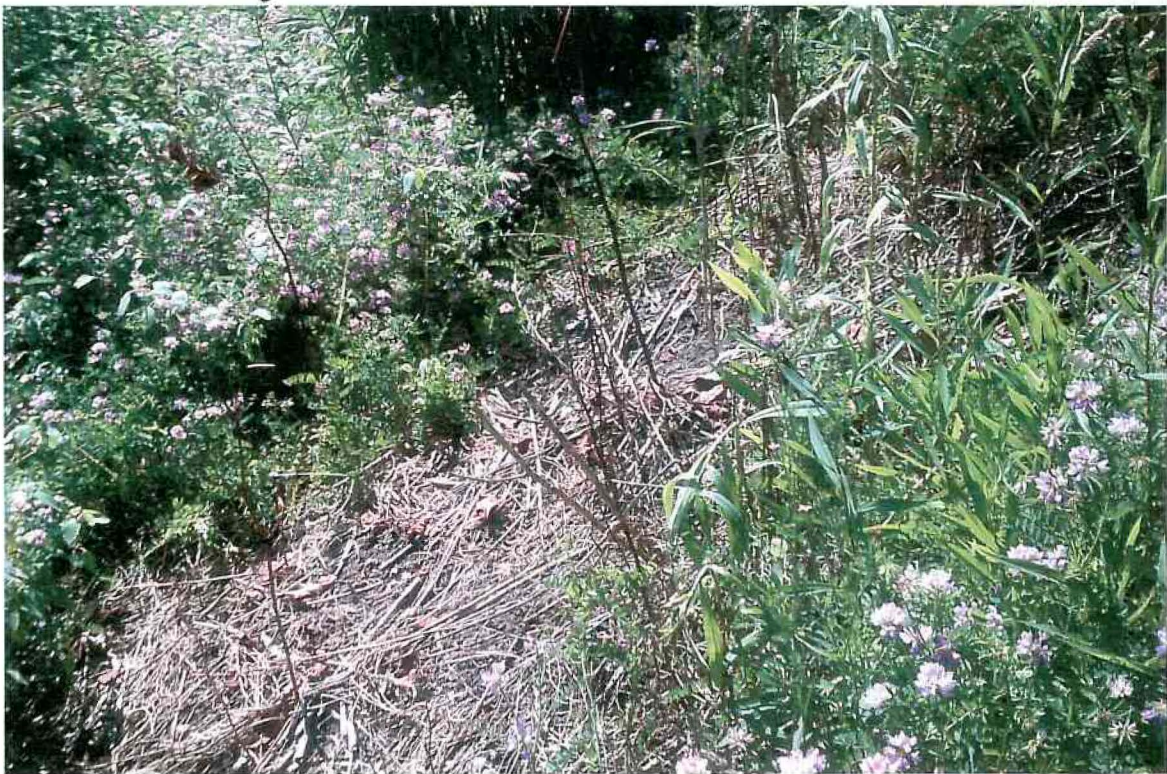
DEAD JAPANESE KNOTWEED

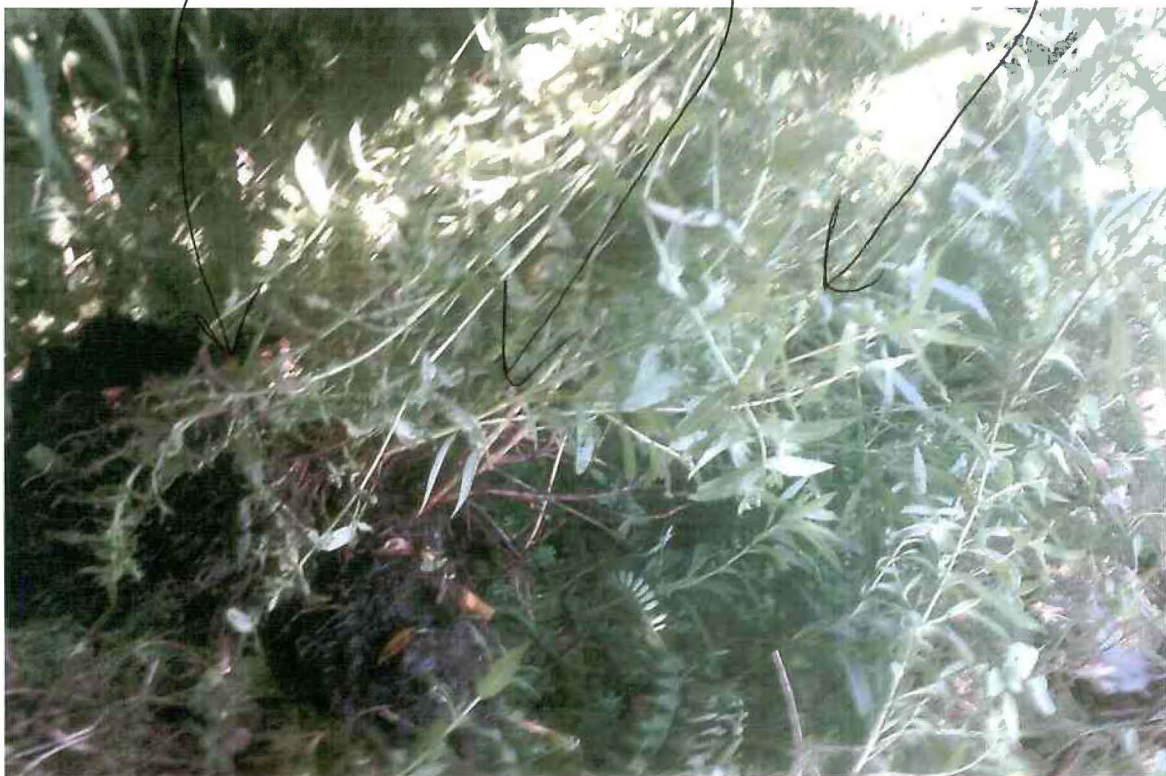
PURPLE LOOSESTRIPE REMOVED

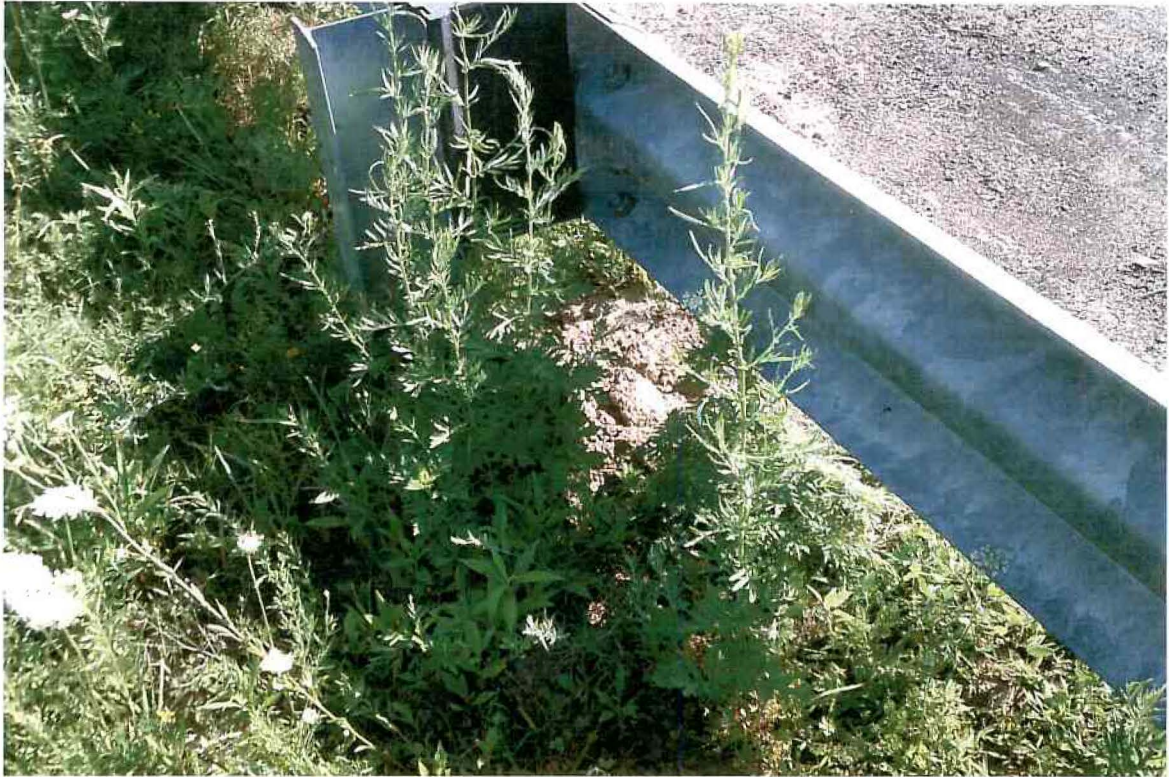
MUGWORT seedlings

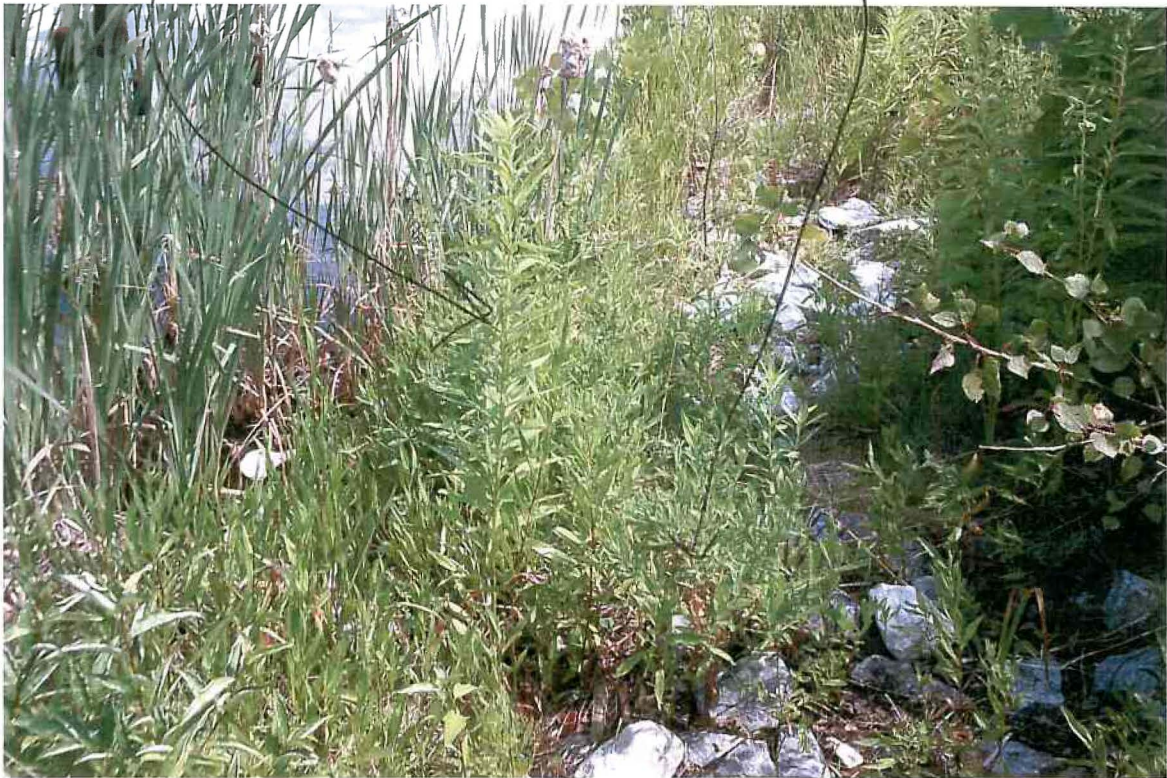
Purple Loosestrife & Colt's Foot

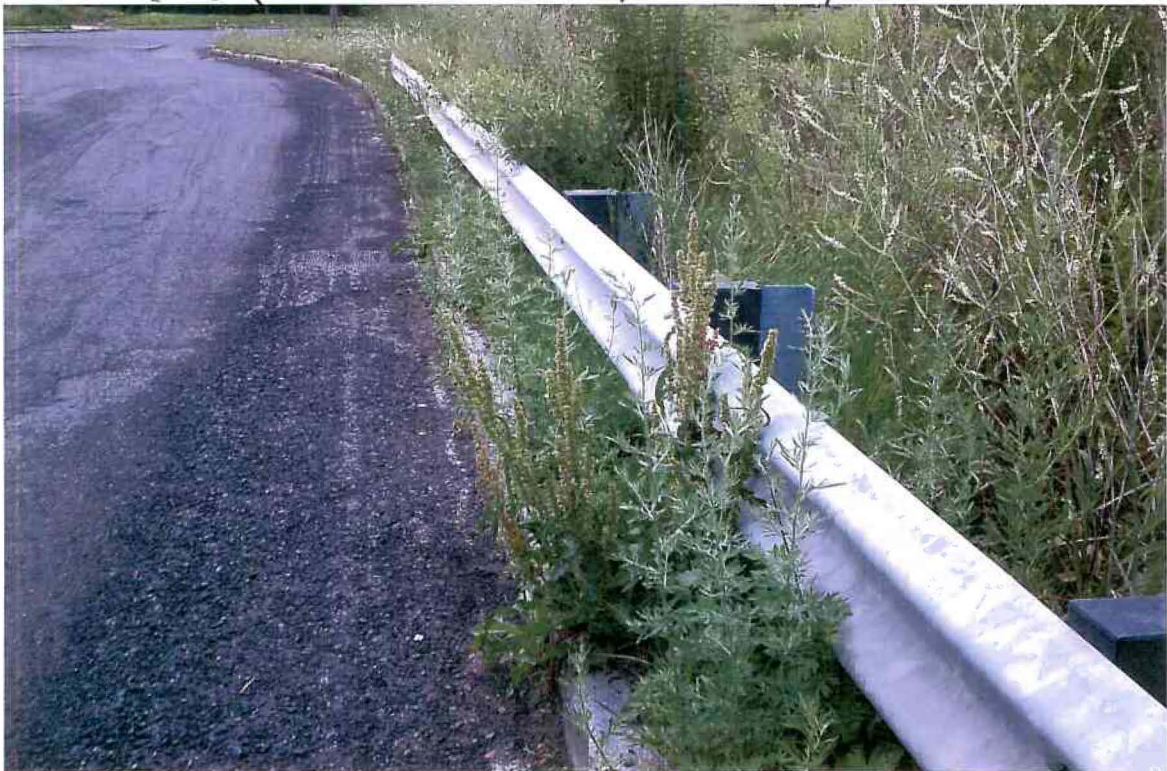
Mugwort and spotted knapweed

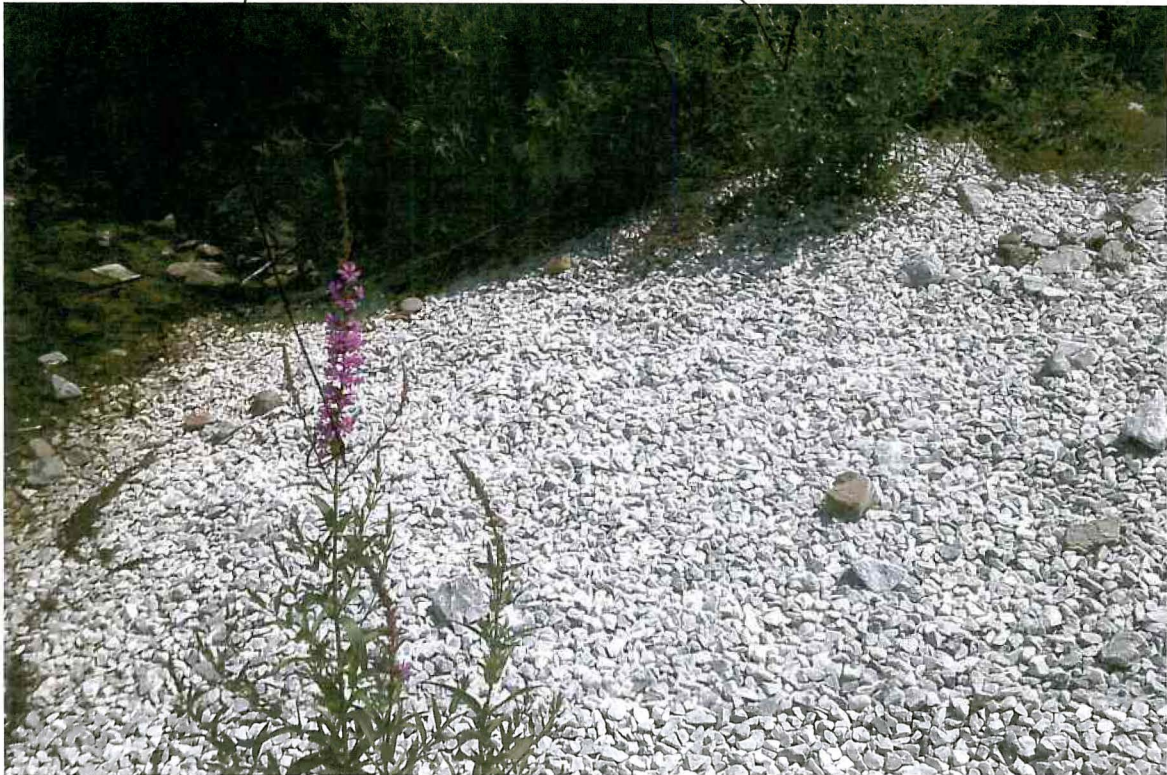
Purple Loosestrife

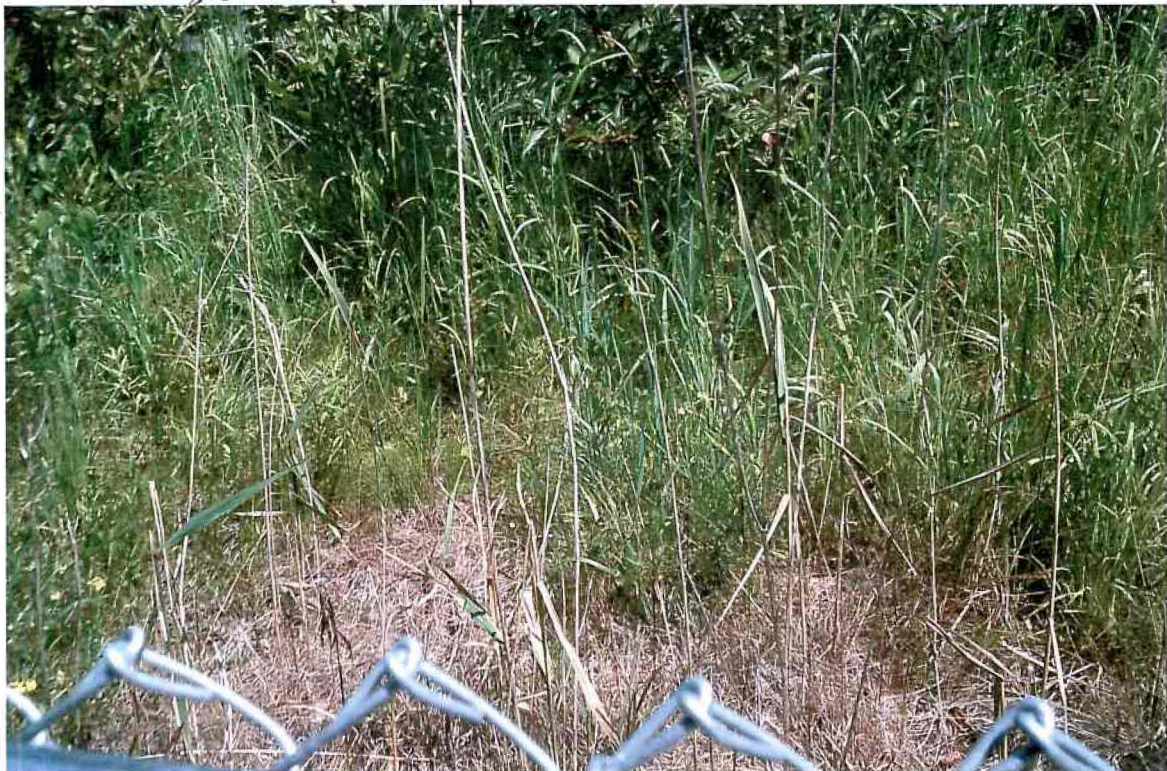
Dead Phragmites

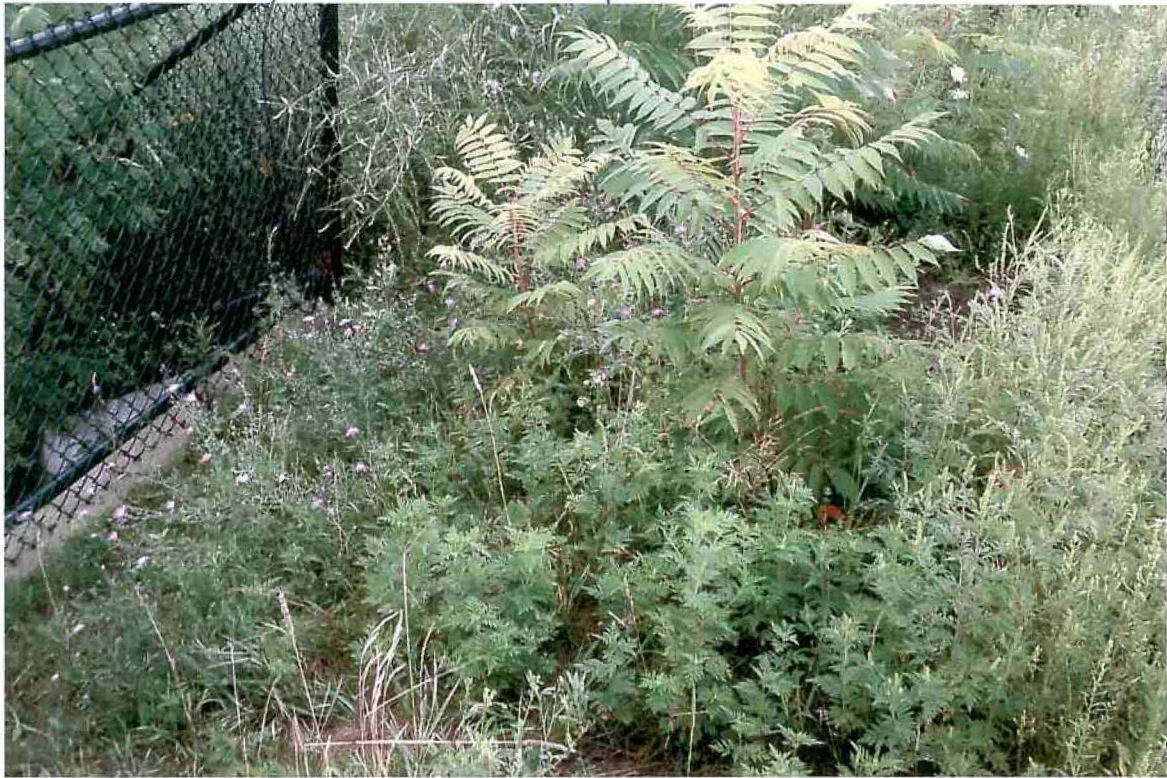
Spotted knapweed patch

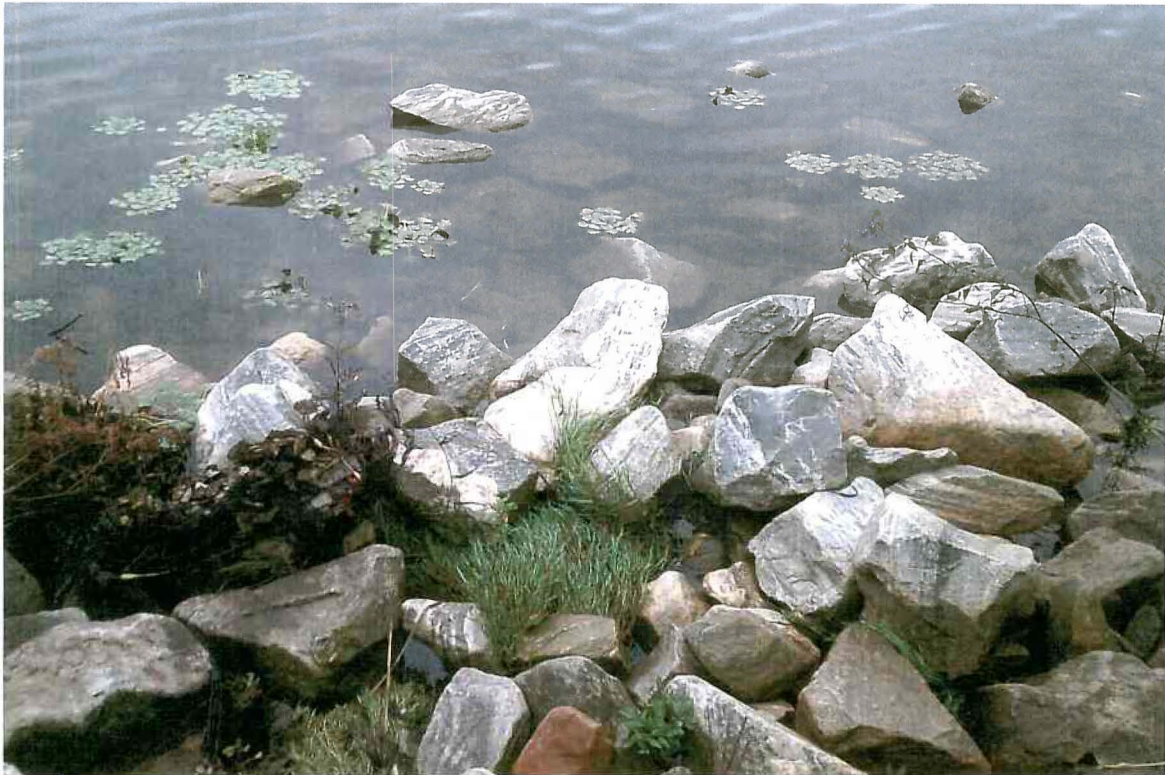
Water chestnut plants found invading Silver Lake through large drain pipe from adjacent pond across Silver Lake Blvd.

Water chestnuts invading

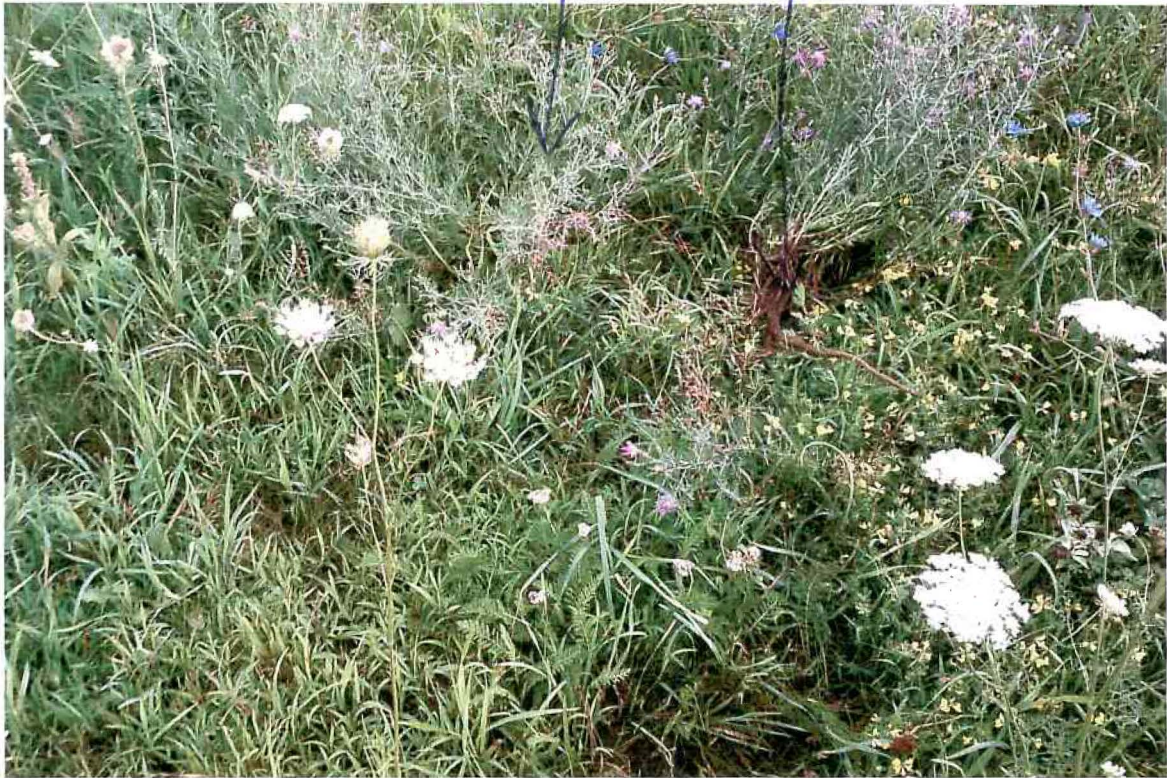
Spotted knapweed

Large taproot  
removed

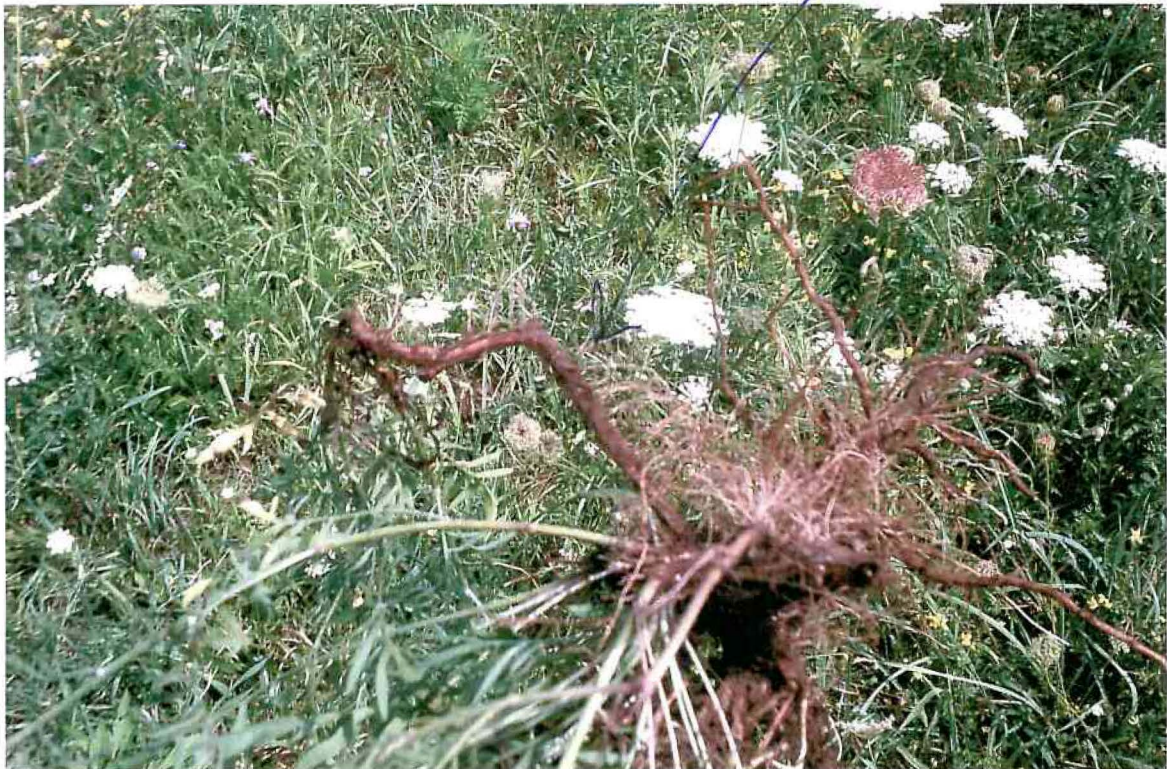
Large Spotted Knapweed root Large

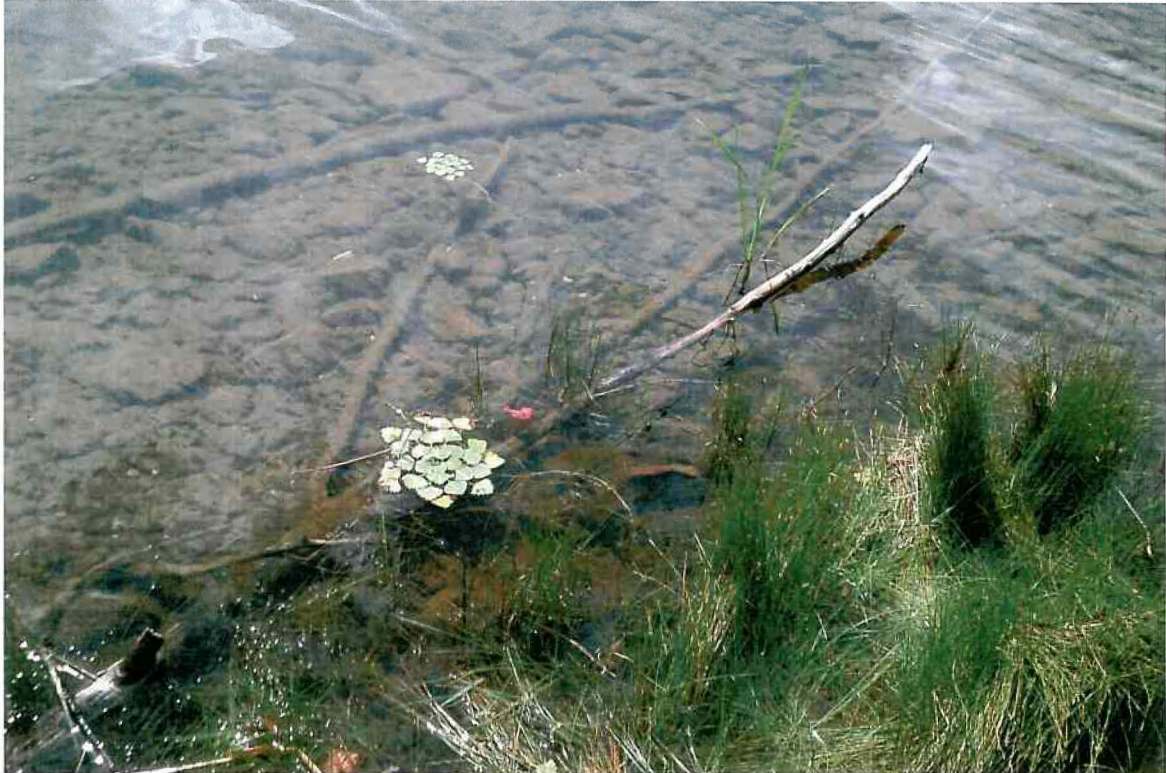
Water Chestnut

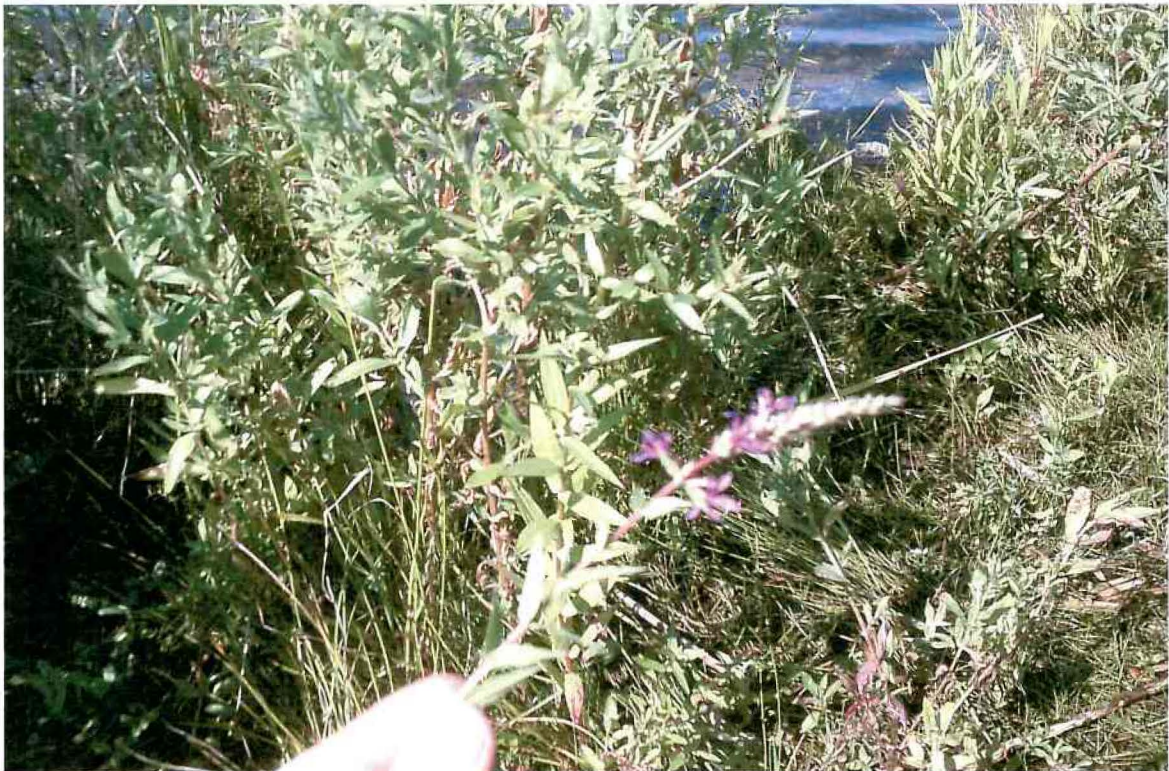
Purple Loosestrife

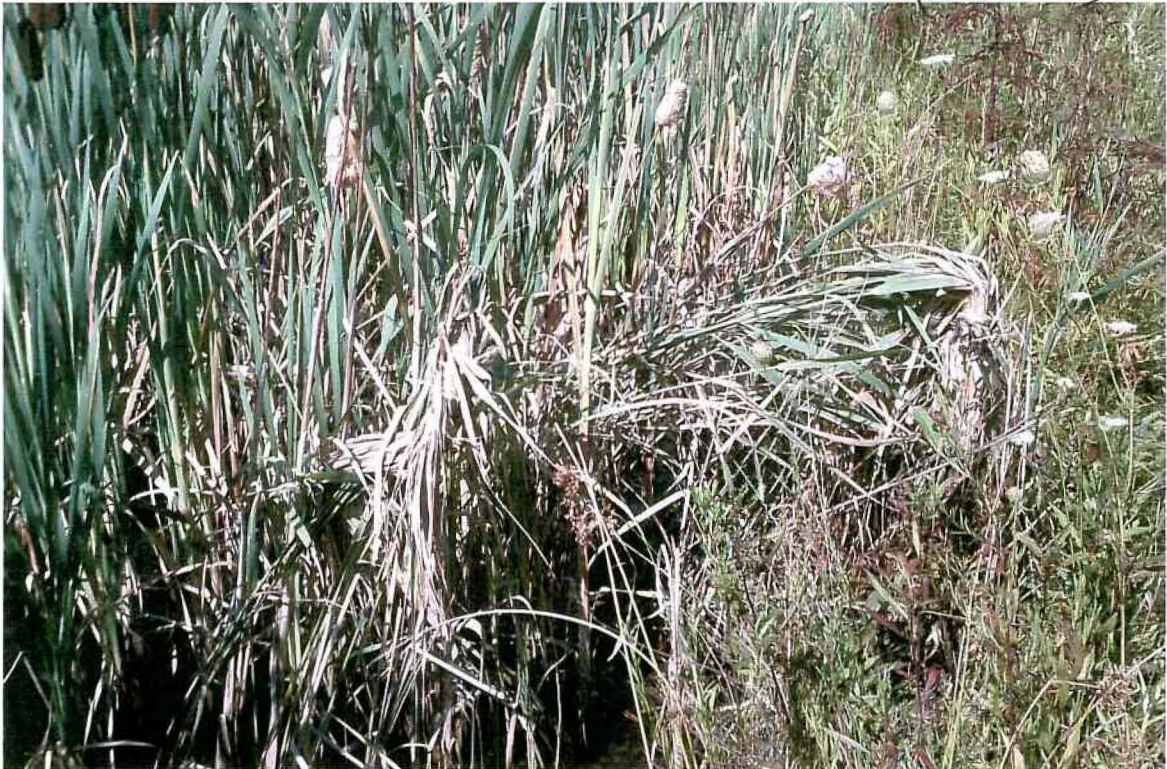
PHRAGS Treated 5<sup>th</sup> treatment (DEAD)
